# Manhole Inspection Summary

Manhole # S25CC1002MH

Insp Date: **1/24/07 3:08 PM**

**Location** Address: **3648 HICKORY AVE**

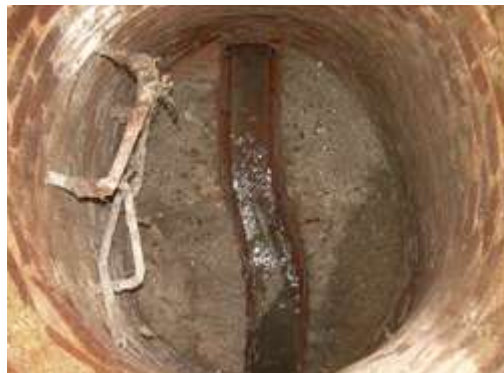
Top View

Evidence of surcharge - Bench debris.  
Channel debris.

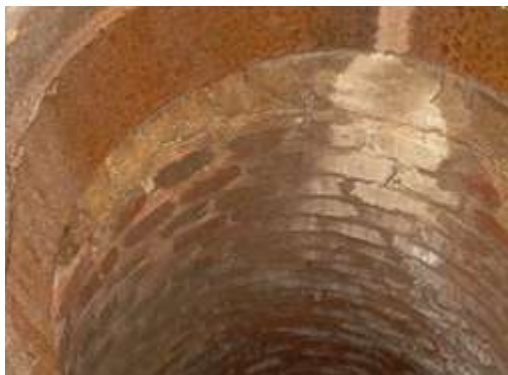
Defect

Frame leaks. Adjustment and Barrel infiltration.

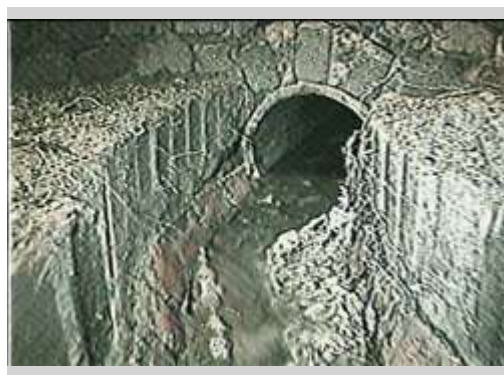
Defect

Barrel deterioration, root intrusion and infiltration. Channel deterioration and root intrusion.

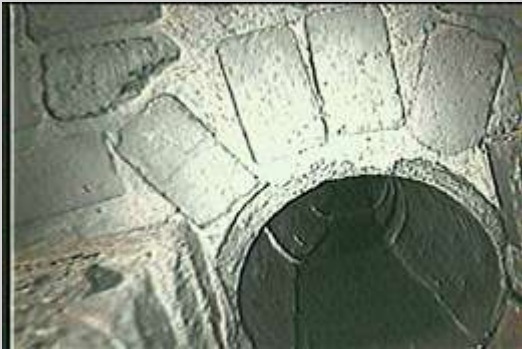
### 8 in. Circular Gravity Sewer Pipe Out @ 12 O'Clock

Deposits: ☒ None ☐ **Mud** ☐ Sludge ☐ **Debris** ☐ Grease

Infiltration: **Evidence** Pipe Seal Cond: **Unknown**

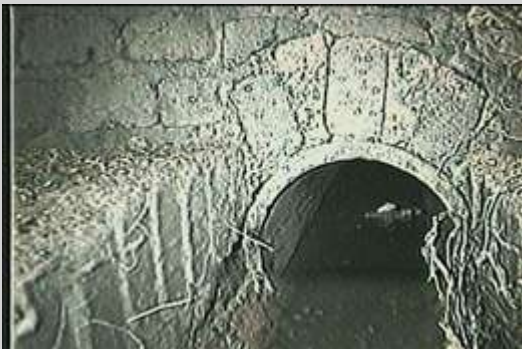
### 8 in. Circular Gravity Sewer Pipe In @ 6 O'Clock

Deposits: ☐ None ☒ **Mud** ☐ Sludge ☒ **Debris** ☐ Grease

Silt Depth: **0.5** (in.) Deposits Extent: **Light**

Infiltration: **Evidence** Pipe Seal Cond: **Roots**
